# *Case Study - Dartington Tweed Mill*

*Weir and fish pass rebuilt,  
waterwheel reused for  
generation*

Site: Dartington Tweed Mill  
Turbine: Historic local wheel  
Power: 3kW  
Head: 3.5m

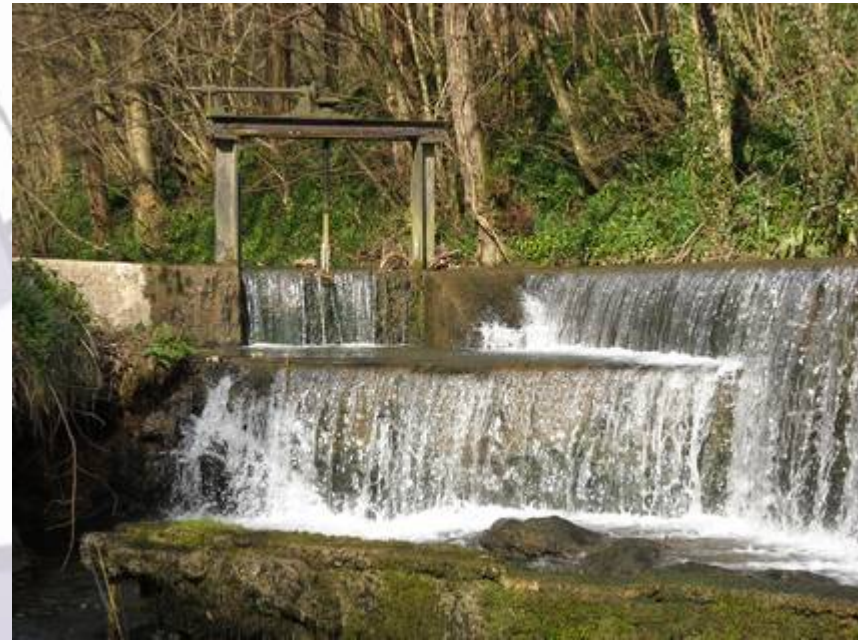
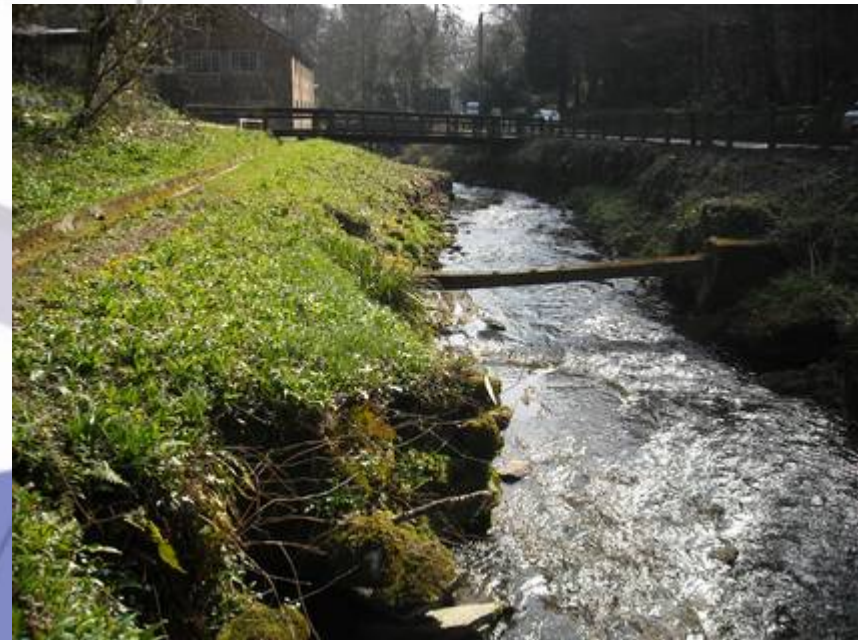
Existing waterwheel has been maintained as amenity for many years, WRE proposed a number of options, the most appropriate being judged to be retention of the wheel with gearbox fitted. The weir required repair as the increased level of abstraction needed to leave the deprived stretch navigable by migratory fish. Space was very limited beside the main road.

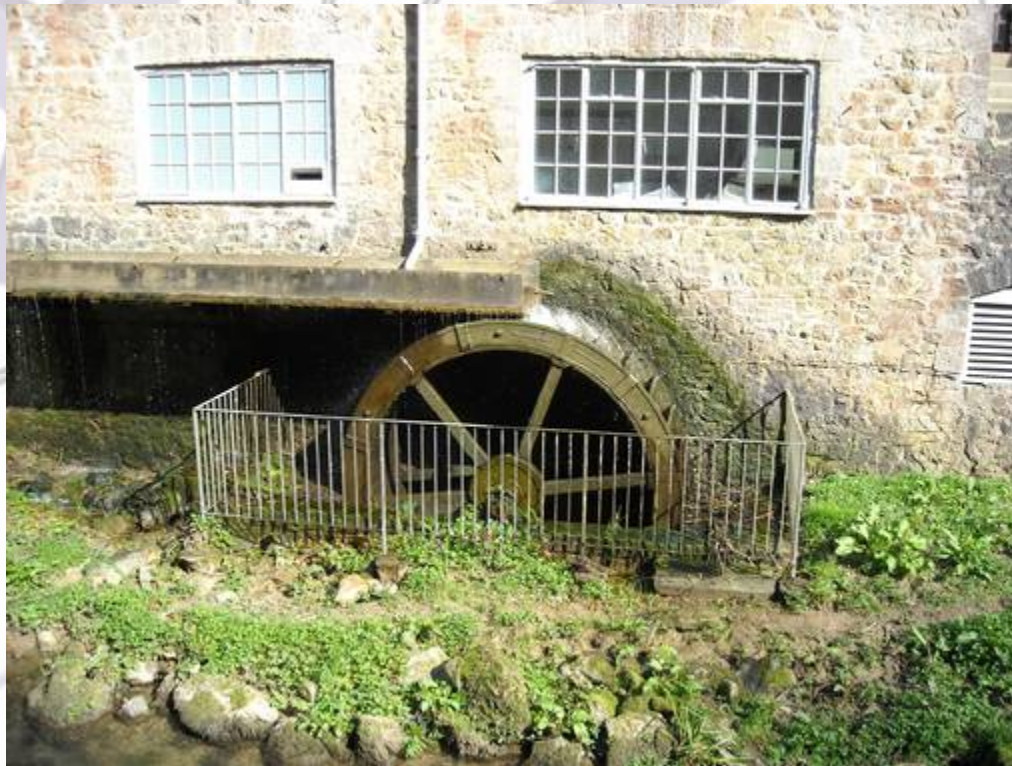
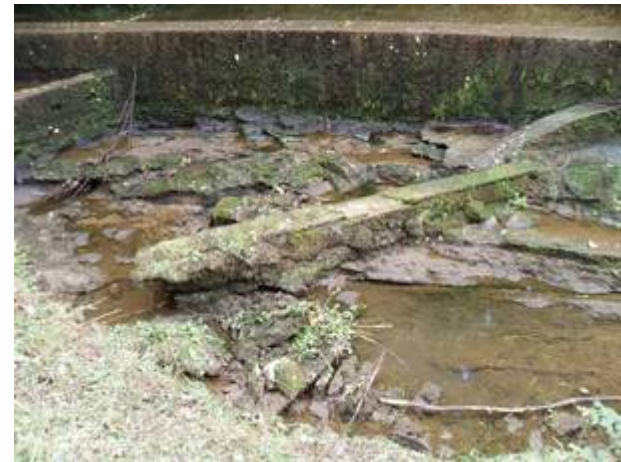
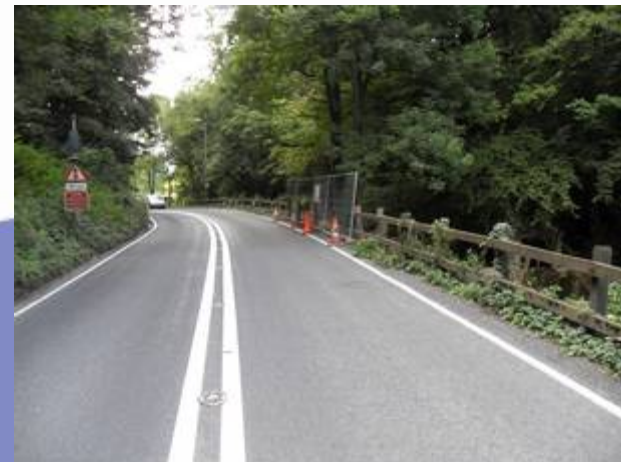
The work at the weir included excavation of banks and replacement with concrete and stone banks, as well as bed lowering below weir pools

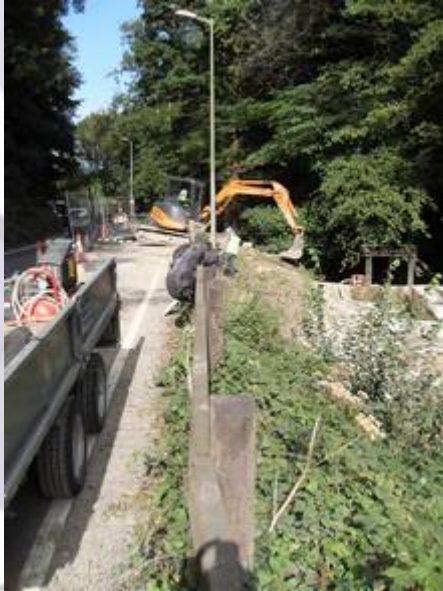
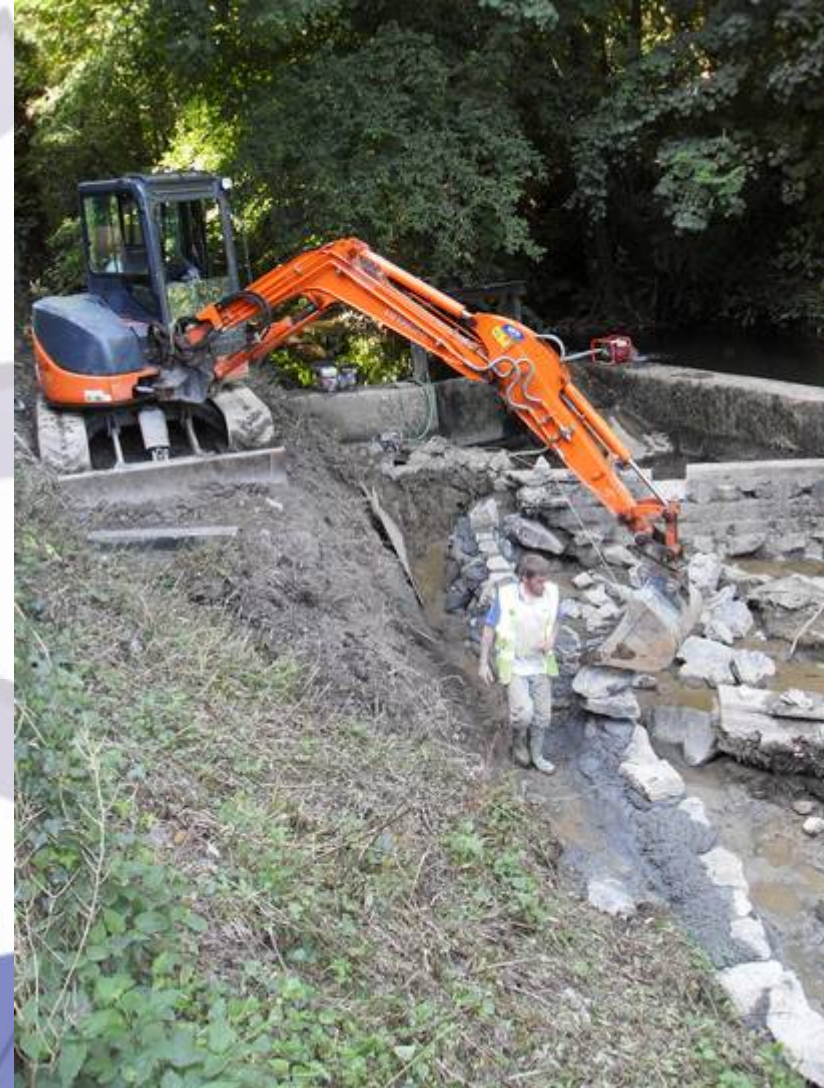
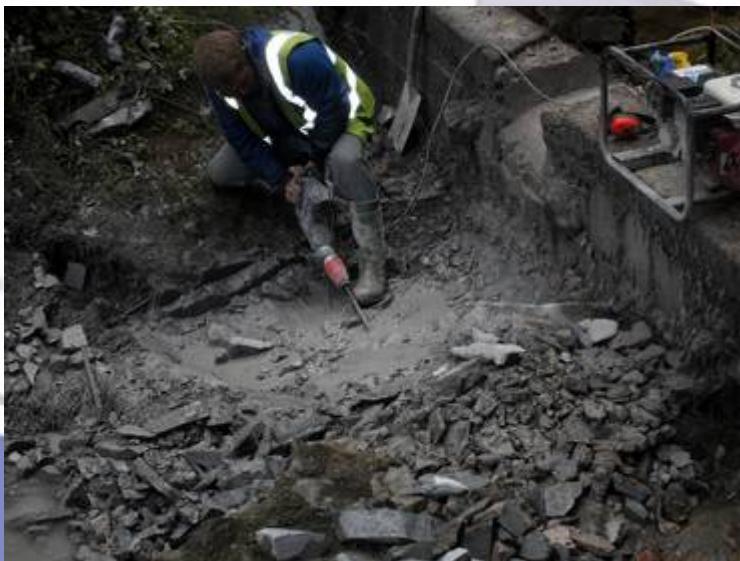
After completion the reserve flow was being used more efficiently for fish passage, and otter passage was improved by the inclusion of a ramp on the riverside

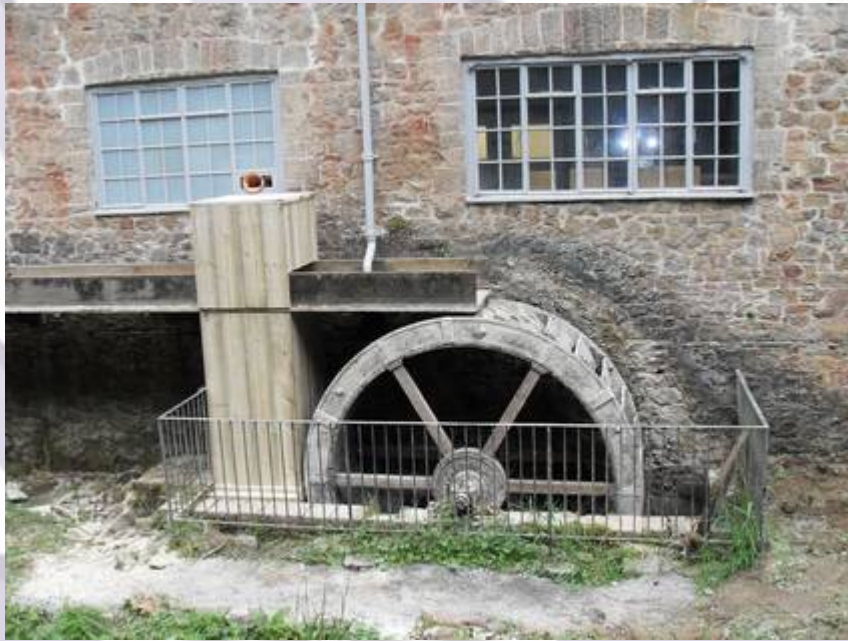
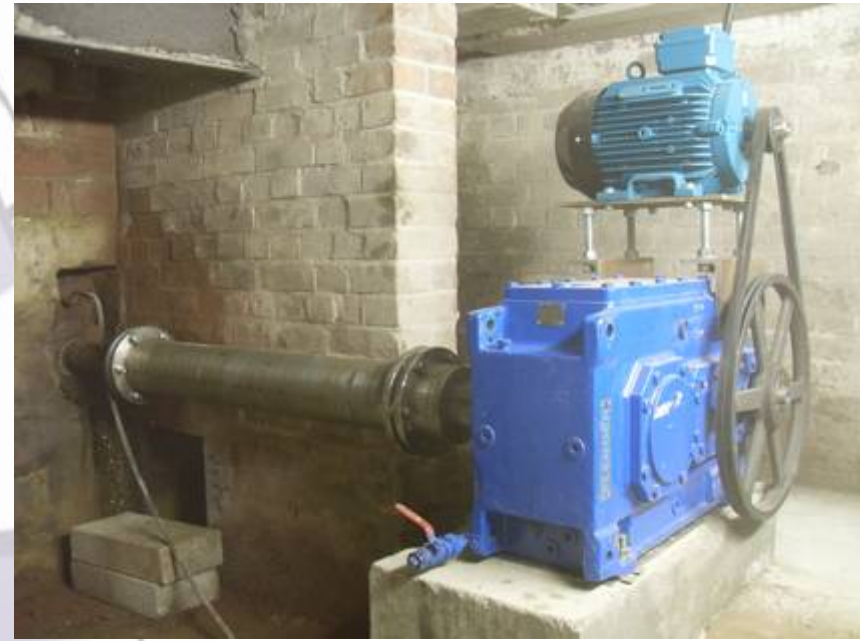
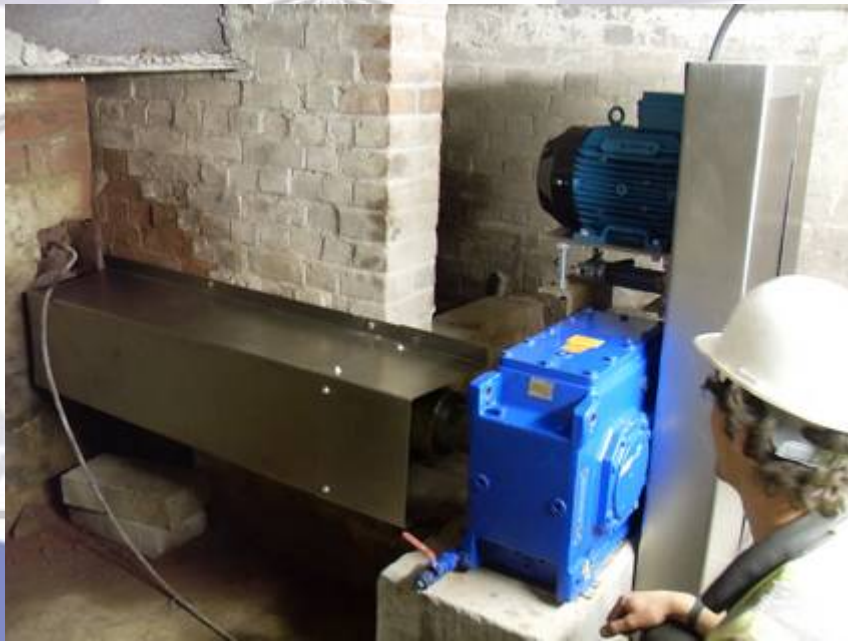
Work at the wheel amounted to installation of a new water diverting flap, to allow the water to be easily diverted if required. In the mill an extension shaft was fitted, and gearbox and generator used in the tightly confined mill basement.
